Manhole Inspection Summary

Manhole # S23GG1001MH

Insp Date: **12/11/06 2:32 PM**

Location Address: **1363 WELDON AVE**

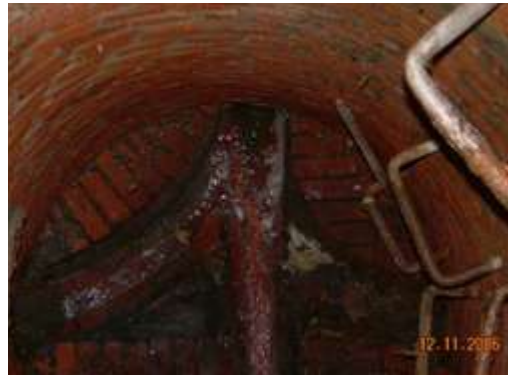
Top View

Corroded steps. Bench and Channel debris.

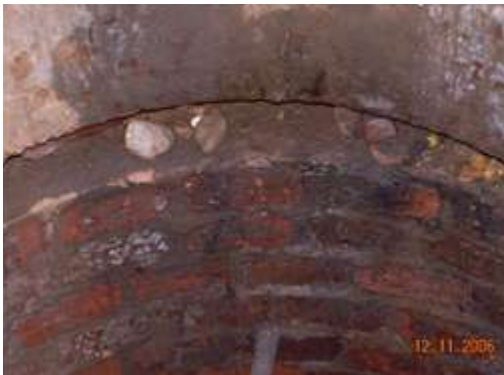
Defect

Frame Offset: **0** (in.) Condition: ☐ Sound ☐ Cracked ☒ **Leaks**

Condition: ☐ Sound ☐ Cracked ☐ Root Intrusion ☐ Loose Brick ☒ **Deteriorated**

Infiltration: ☐ None ☒ **Joint** ☐ Cracks ☒ **Mortar** ☐ Roots ☐ Wall

Frame leaks. Adjustment deterioration and infiltration.

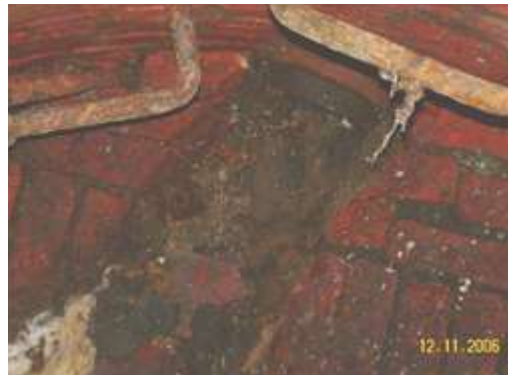
Defect

Condition: ☐ Sound ☐ Cracked ☐ Root Intrusion ☒ **Deteriorated** ☐ Leaks ☐ Debris

Channel deterioration.

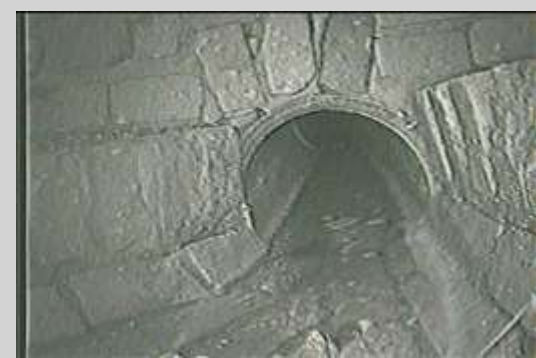
8 in. Circular Gravity Sewer Pipe Out @ 12 O'Clock

Condition: ☐ Sound ☐ Cracked ☐ Root Intrusion ☐ Loose Brick ☒ **Deteriorated**

Infiltration: ☐ None ☐ Joint ☐ Cracks ☒ **Mortar** ☐ Roots ☐ Wall

Barrel deterioration and infiltration. Channel deterioration.

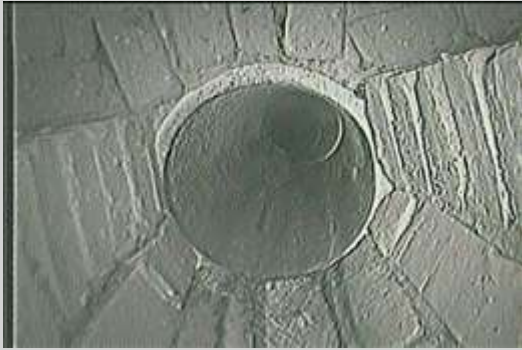
Pipe In @ 6 O'Clock

Channel deterioration.

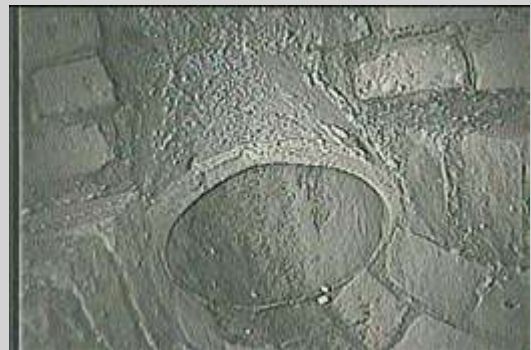
Drop In @ 9 O'Clock

Drop Condition: **Open**
